Marshall Monument / Perth Museum and Art Gallery

Public Sector Case Study

The Brief

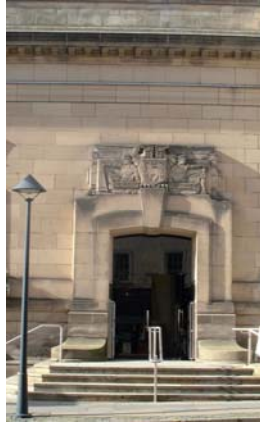
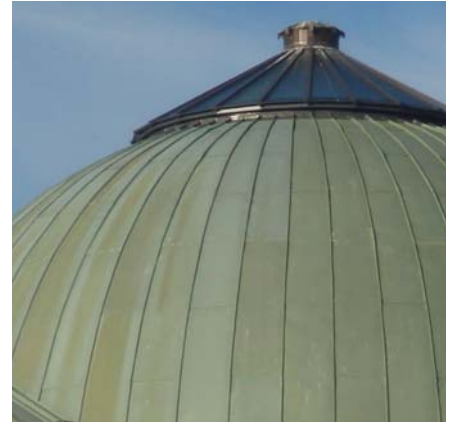
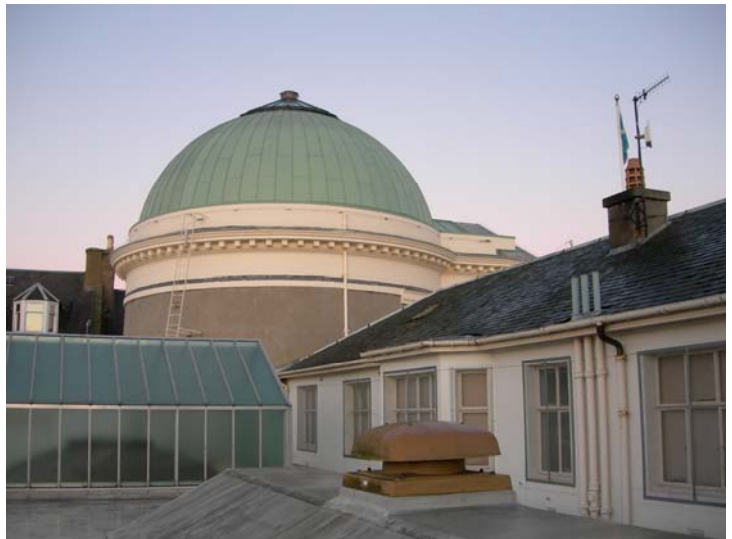
To avoid negative press for our client, the existing copper was replaced with a pre-patinated copper sheet matching the colour of the copper sheeting removed and the cupola was completely replaced with a new steel

structure and glazing to provide adequate ventilation as well as a water tight skin. The internal cast iron structure was completely stripped back by hand and treated with anti-corrosion coatings. New floors were constructed within the actual dome to provide easier access for future maintenance and repairs.
